**Flood Control Project Maintenance
Levee Inspections
2008 Channel Summary Report
Overall Unit and Item Ratings**

DWR Sutter Maintenance Yard

Flood Control Project Maintenance
Inspection Report - Channel 2008

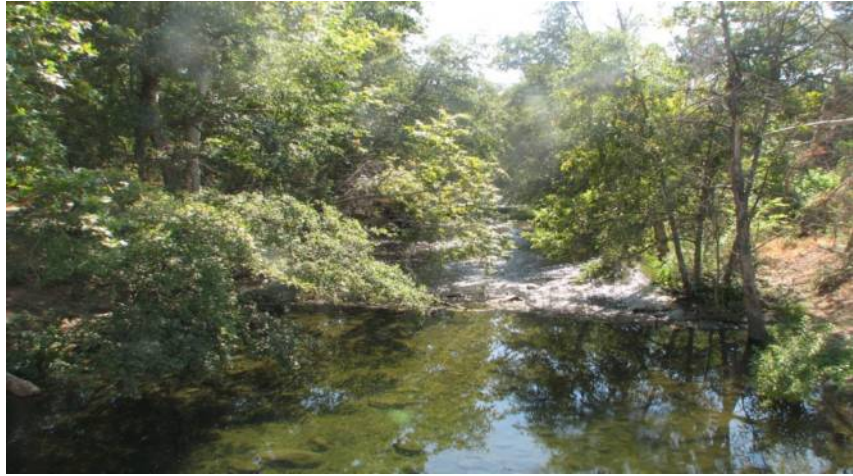
Report Line	1
Location	
Category	Rivers, Channels & Designated Floodways
Item	Vegetation & Obstructions

Downstream from the big Chico Creek Control Structure.

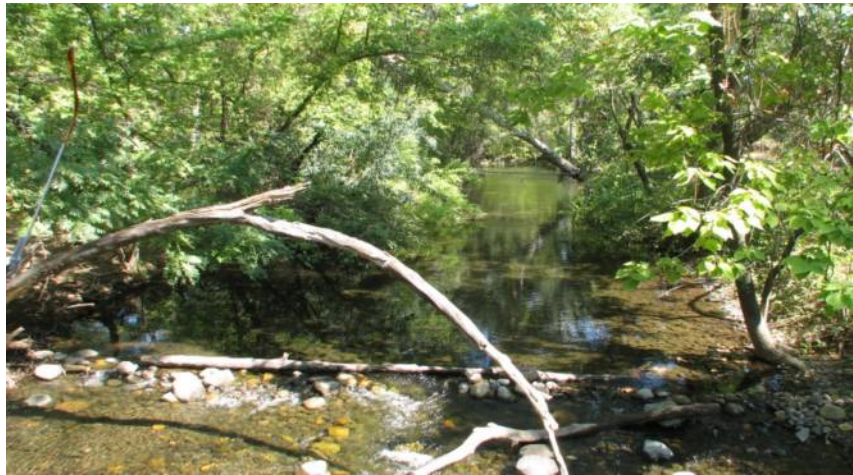
Report Line	2
Location	
Category	Rivers, Channels & Designated Floodways
Item	Vegetation & Obstructions

Upstream from bridge near Forest Avenue heavy growth along both banks.

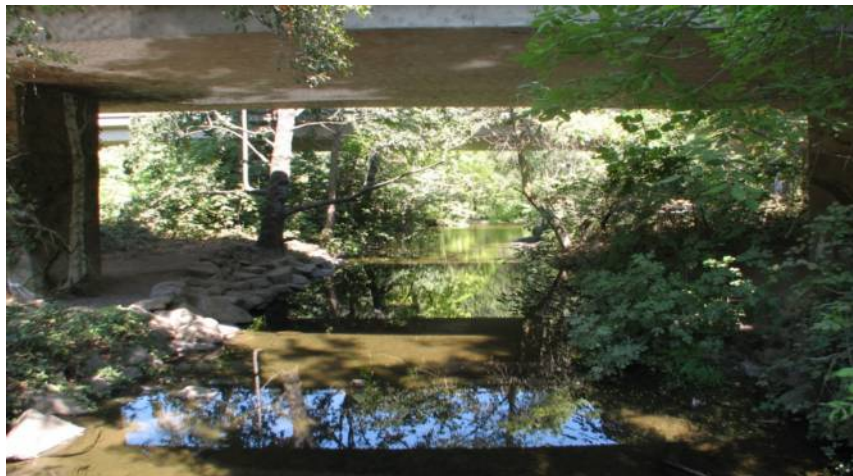
Report Line	3
Location	
Category	Rivers, Channels & Designated Floodways
Item	Vegetation & Obstructions

Upstream from Hwy. 99 growth along both banks.

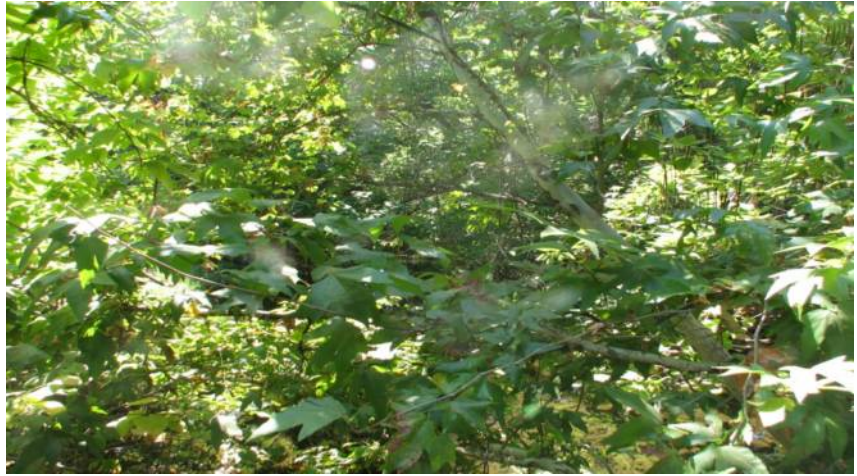
Report Line	4
Location	
Category	Rivers, Channels & Designated Floodways
Item	Vegetation & Obstructions

Downstream from Hwy 99 dense vegetation in channel.

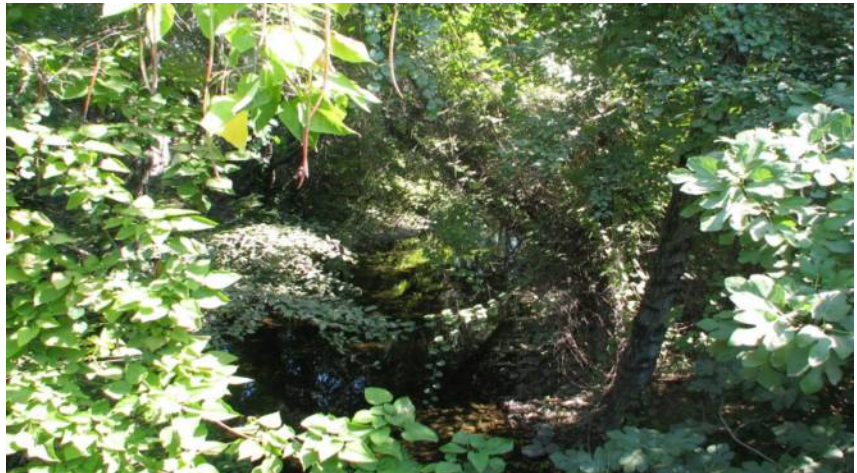
Report Line	5
Location	
Category	Rivers, Channels & Designated Floodways
Item	Vegetation & Obstructions

Upstream from the Esplanado heavy growth on both banks.

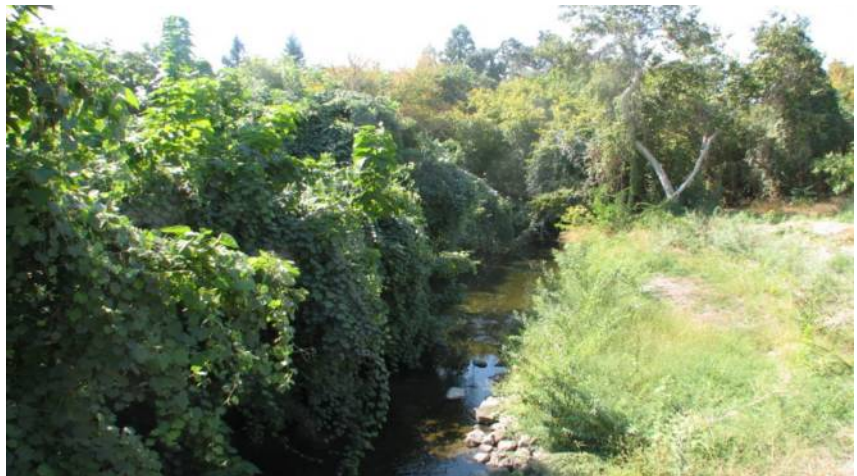
Report Line	6
Location	
Category	Rivers, Channels & Designated Floodways
Item	Vegetation & Obstructions

Downstream from Hwy. 32 heavy growth on both banks.

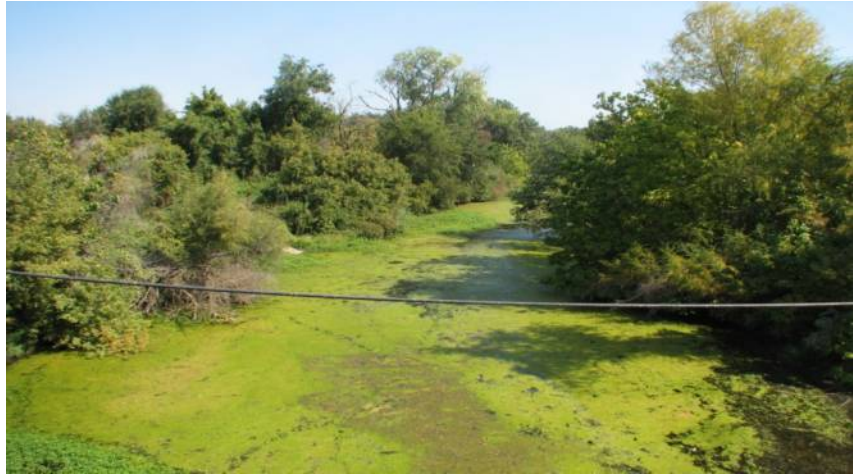
Report Line	7
Location	
Category	Rivers, Channels & Designated Floodways
Item	Vegetation & Obstructions

Upstream approximately 500 feet from the confluence with the Sacramento River.

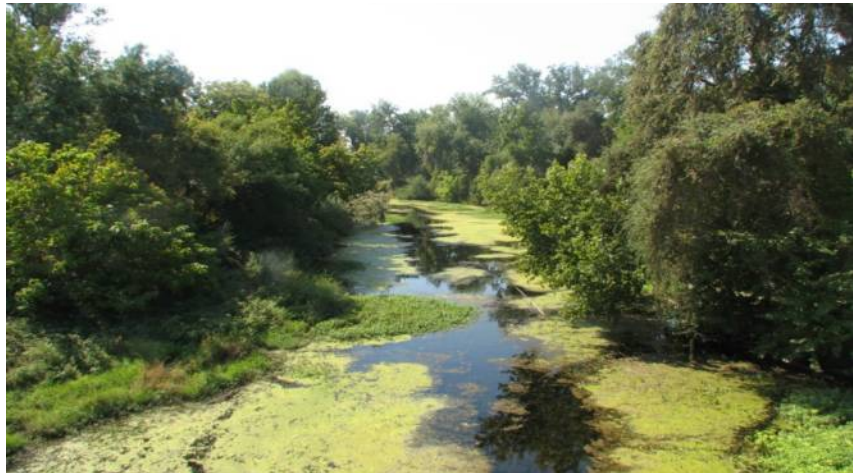
Report Line	8
Location	
Category	Rivers, Channels & Designated Floodways
Item	Vegetation & Obstructions

Downstream towards the confluence with the Sacramento River.

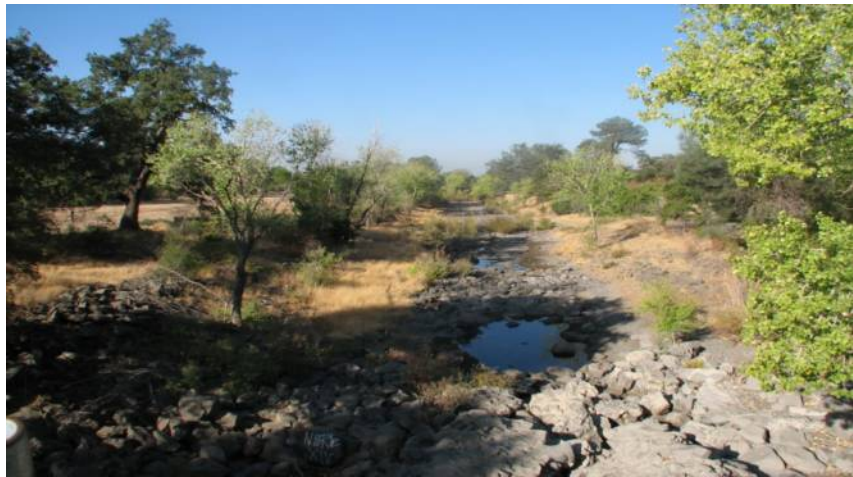
Report Line	1
Location	
Category	Rivers, Channels & Designated Floodways
Item	Vegetation & Obstructions

Downstream from the Lindo Channel Diversion Structure.

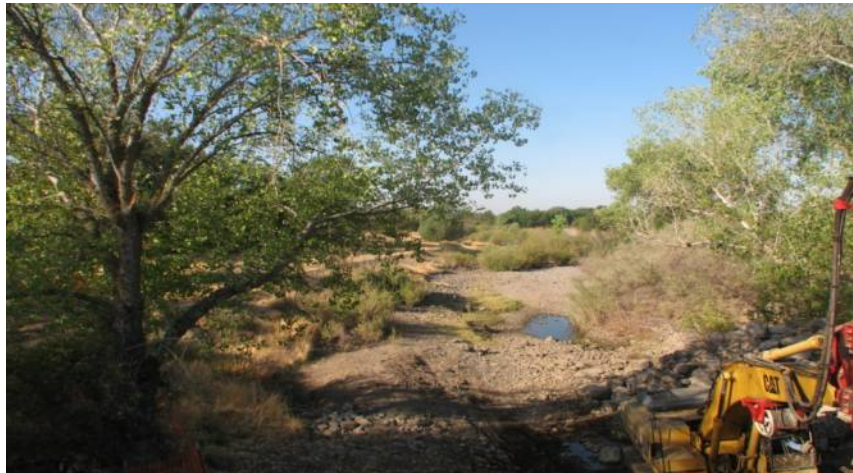
Report Line	2
Location	
Category	Rivers, Channels & Designated Floodways
Item	Vegetation & Obstructions

Downstream from Manzanita Avenue.

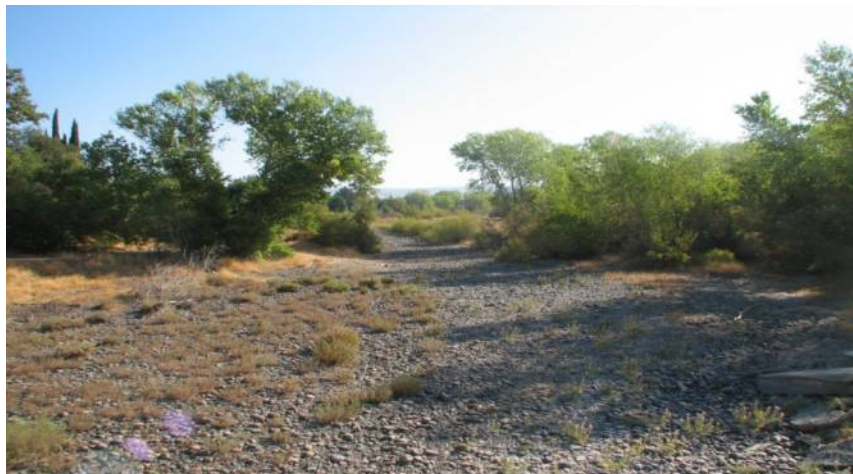
Report Line	3
Location	
Category	Rivers, Channels & Designated Floodways
Item	Vegetation & Obstructions

Upstream from the bike path bridge at the extension of Madrone Avenue.

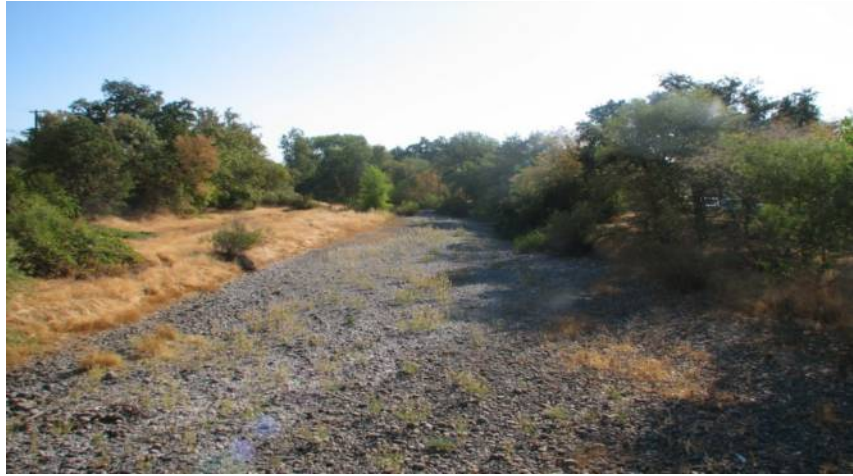
Report Line	4
Location	
Category	Rivers, Channels & Designated Floodways
Item	Vegetation & Obstructions

Upstream from Mariposa.

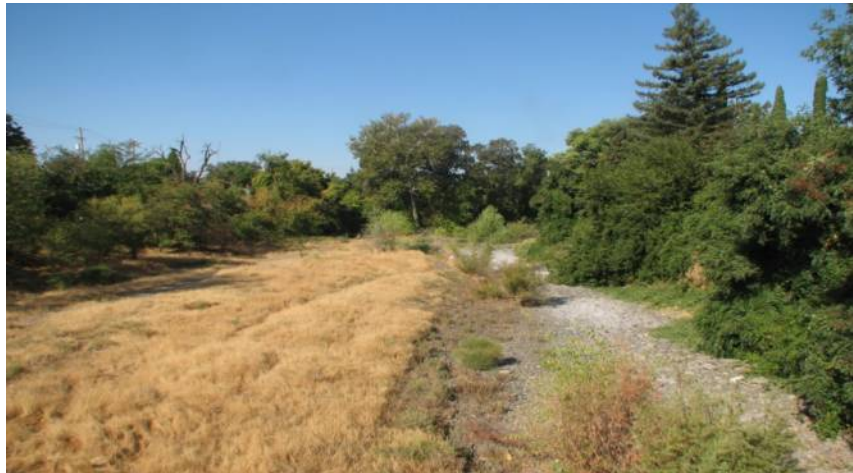
Report Line	5
Location	
Category	Rivers, Channels & Designated Floodways
Item	Vegetation & Obstructions

Downstream from the Esplanade.

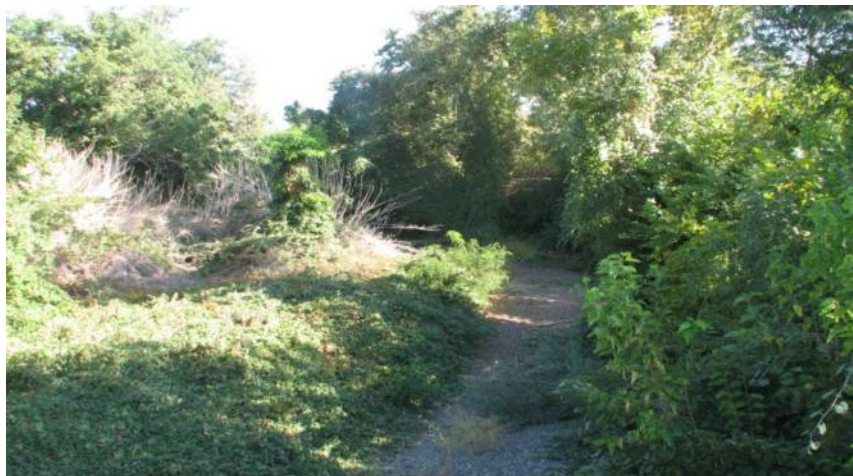
Report Line	6
Location	
Category	Rivers, Channels & Designated Floodways
Item	Vegetation & Obstructions

Upstream from Hwy. 32.

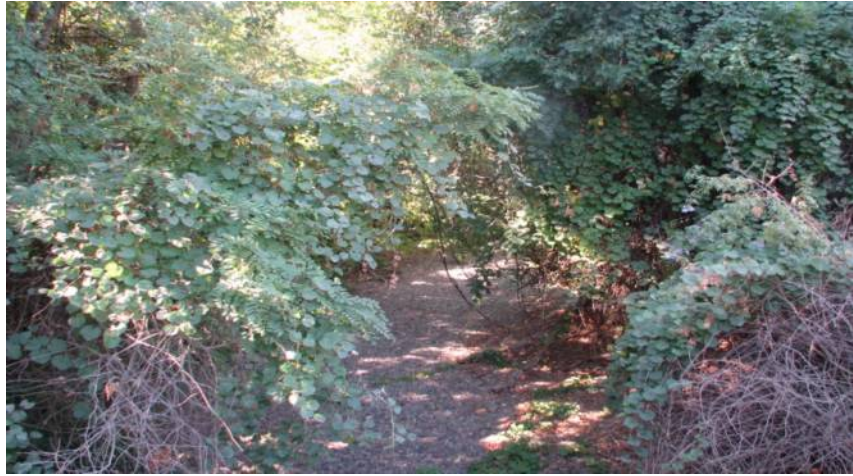
Report Line	7
Location	
Category	Rivers, Channels & Designated Floodways
Item	Vegetation & Obstructions

Downstream from Oak Avenue.

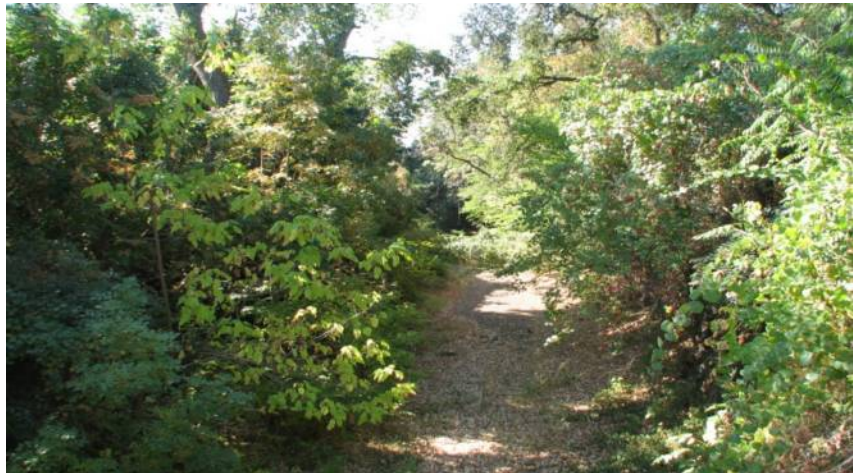
Report Line	8
Location	
Category	Rivers, Channels & Designated Floodways
Item	Vegetation & Obstructions

Downstream from Grape Way heavy vegetation.

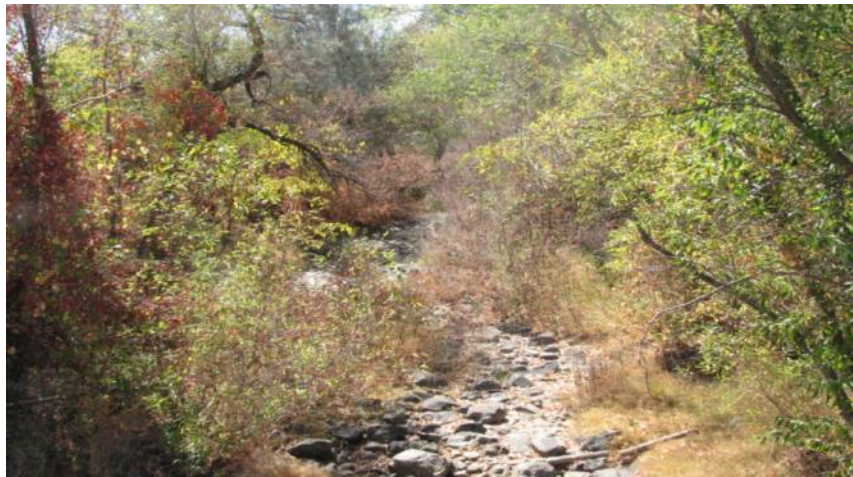
Report Line	1
Location	
Category	Rivers, Channels & Designated Floodways
Item	Vegetation & Obstructions

Downstream from the control structure on Little Chico Creek.

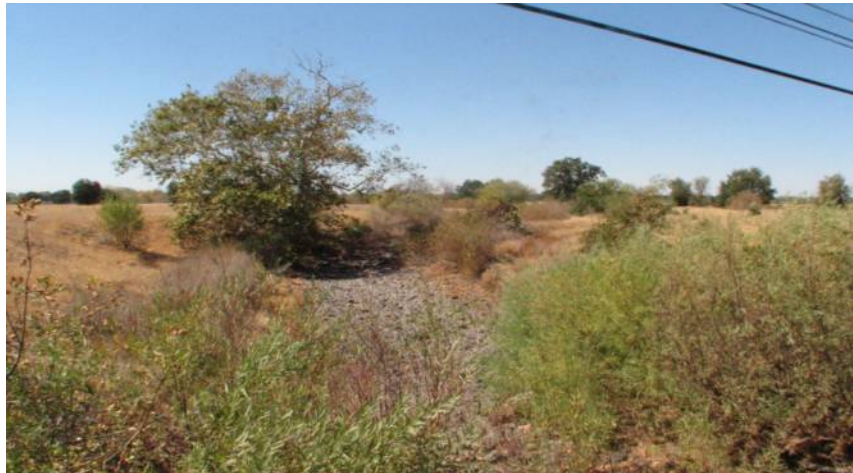
Report Line	2
Location	
Category	Rivers, Channels & Designated Floodways
Item	Vegetation & Obstructions

Downstream from Bruce Road.

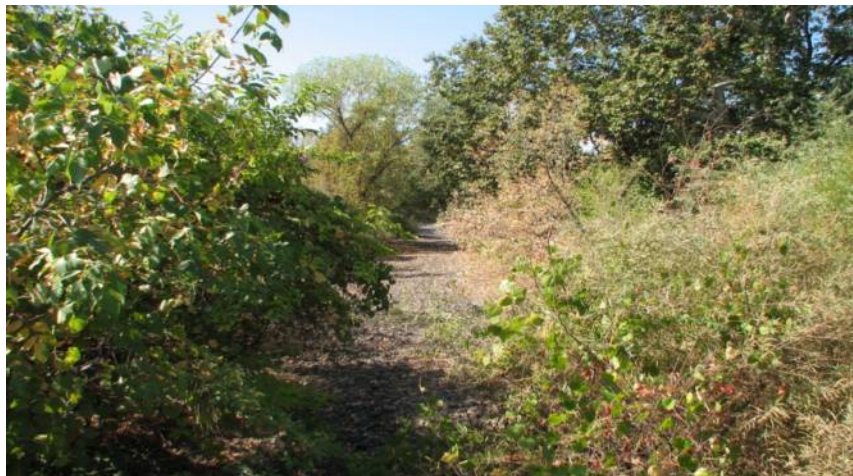
Report Line	3
Location	
Category	Rivers, Channels & Designated Floodways
Item	Vegetation & Obstructions

Downstream from Forest Avenue heavy vegetation.

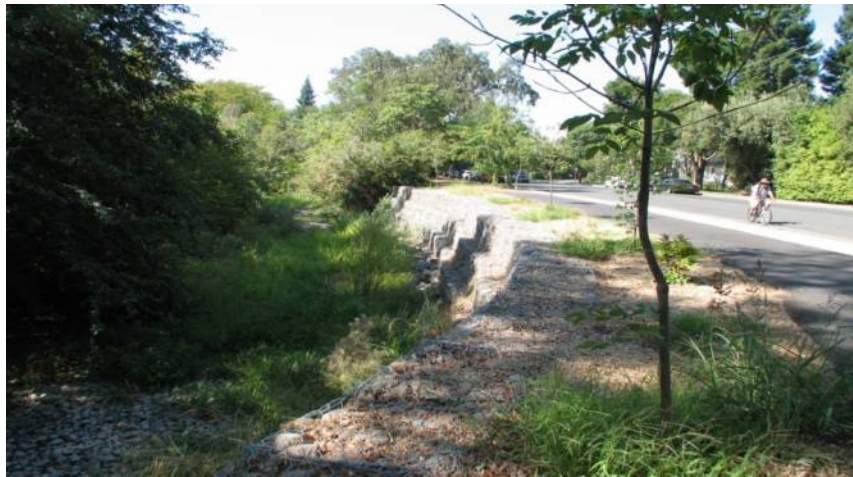
Report Line	4
Location	
Category	Rivers, Channels & Designated Floodways
Item	Vegetation & Obstructions

Erosion repair site, upstream of Hwy.99.

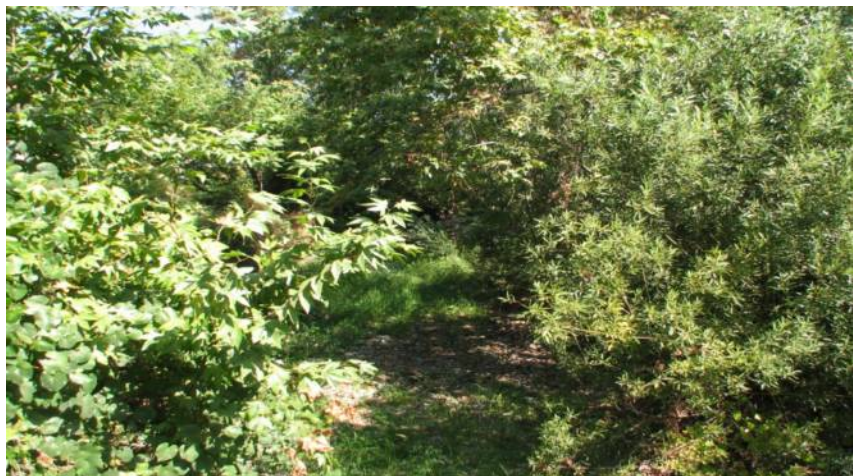
Report Line	5
Location	
Category	Rivers, Channels & Designated Floodways
Item	Vegetation & Obstructions

Upstream from Boucher Street dense growth on both banks.

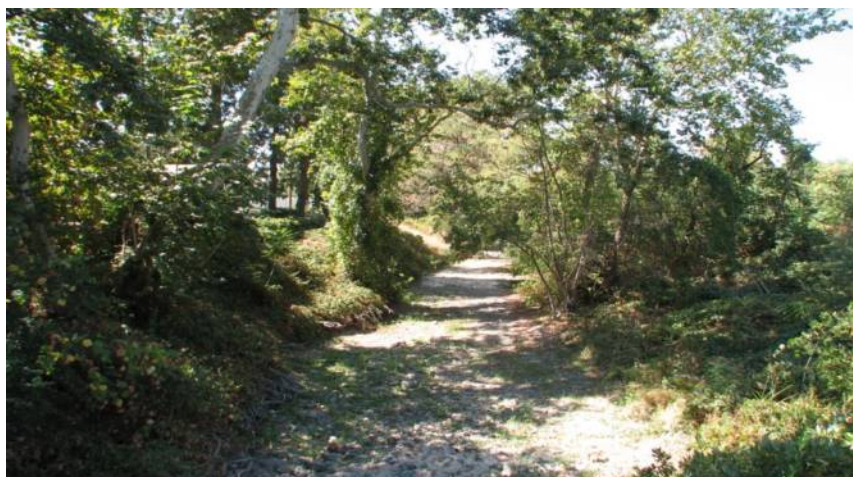
Report Line	6
Location	
Category	Rivers, Channels & Designated Floodways
Item	Vegetation & Obstructions

Downstream from Olive Street.

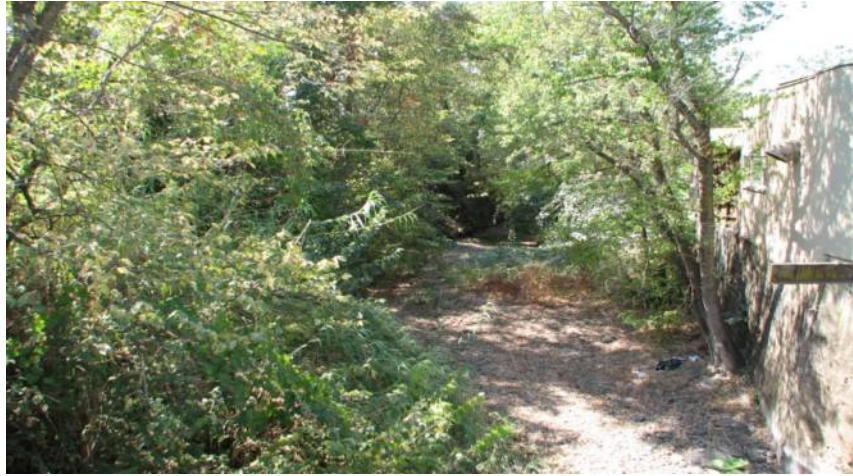
Report Line	7
Location	
Category	Rivers, Channels & Designated Floodways
Item	Vegetation & Obstructions
Downstream from Broadway Street heavy growth on both banks.

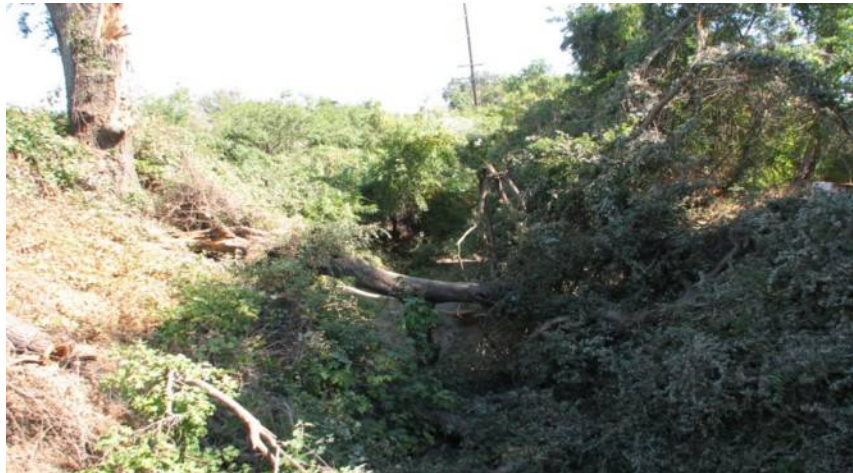
Report Line	8
Location	
Category	Rivers, Channels & Designated Floodways
Item	Vegetation & Obstructions
Upstream from Lone Pine Street large oak in channel.

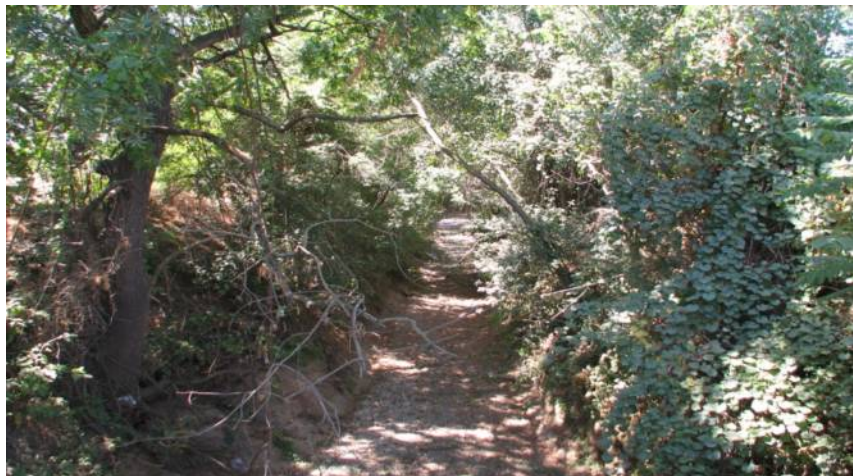
Report Line	9
Location	
Category	Rivers, Channels & Designated Floodways
Item	Vegetation & Obstructions
Downstream from Lone Pine Street heavy growth on both banks.
